**DOT/FAA/AR-96/21**

# **Composite Failure Analysis Handbook Update 1**

**WL-TR-93-4004**

August 1997

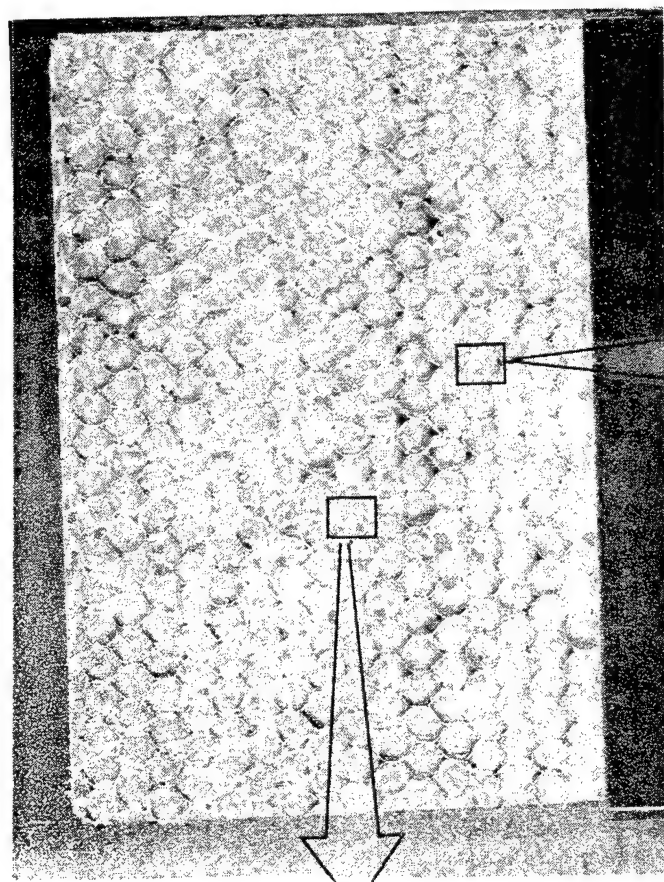
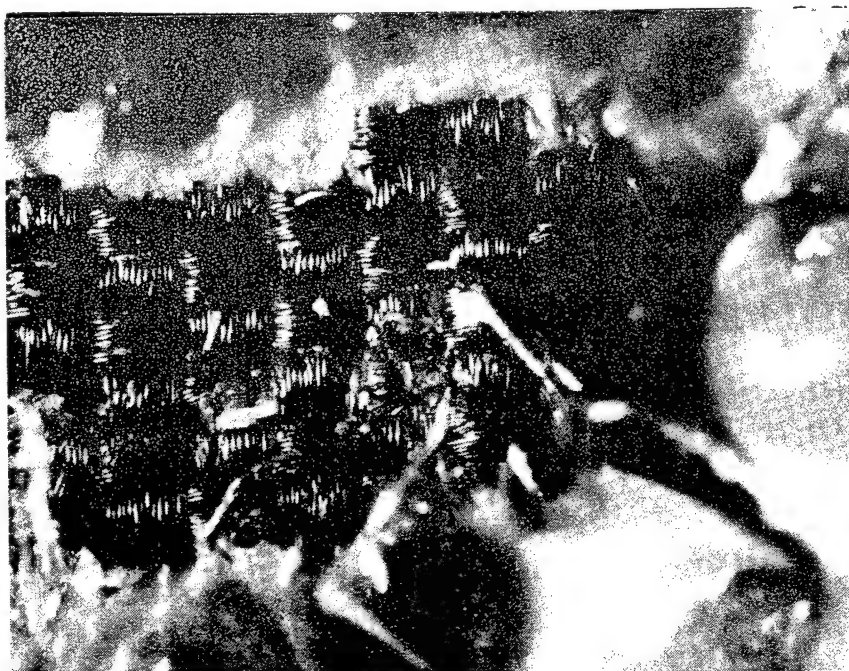
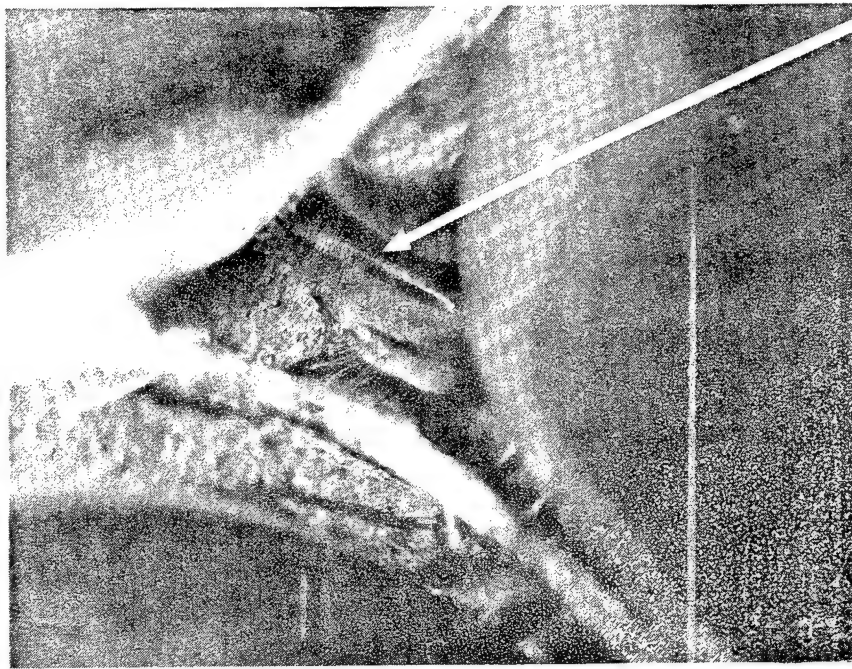
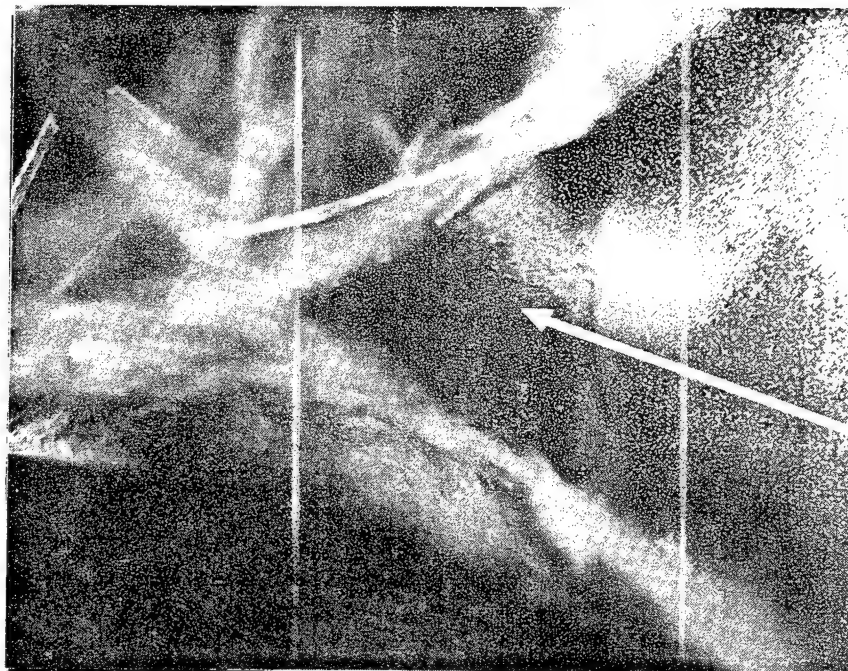
Figure 3.8-11. Optical Fractographs of Mode I Sandwich, Stronger Core Used (8-lb) Specimen  
Sheet 1 of 2

**Eight-Pound Core Specimen.** The failure occurred primarily in the adhesive layer. Both adhesive and cohesive failure was evident. The adhesive failure, between the adhesive and the face sheet, occurred near the center of the specimen. Approximately 25% of the core failure was observed in these specimens. Optical fractographs taken at 200X showed a lower velocity fracture characteristic as evidenced by the mirror and mist fracture features shown in Figure 3.8-11.

Wallner  
lines

Mist

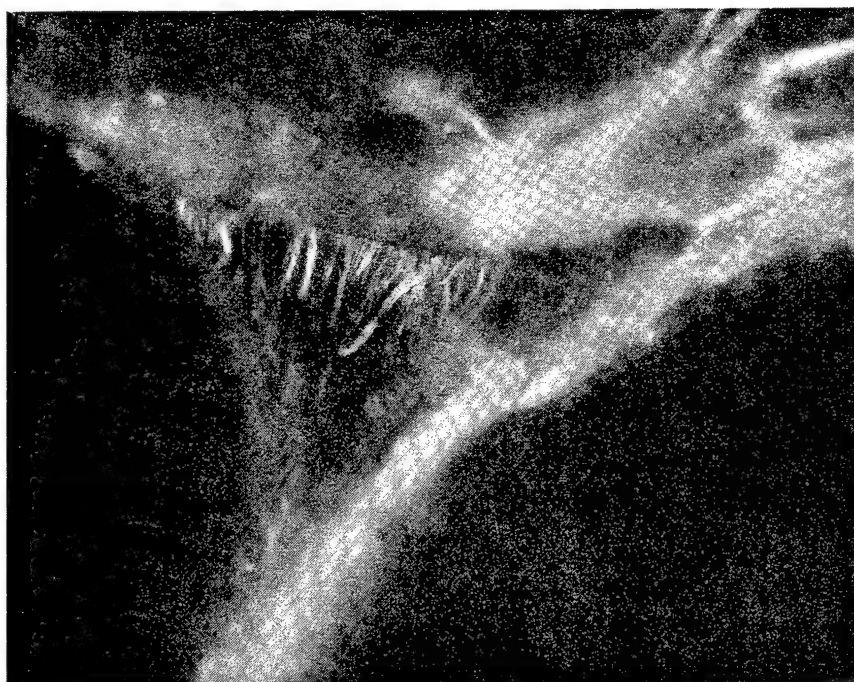
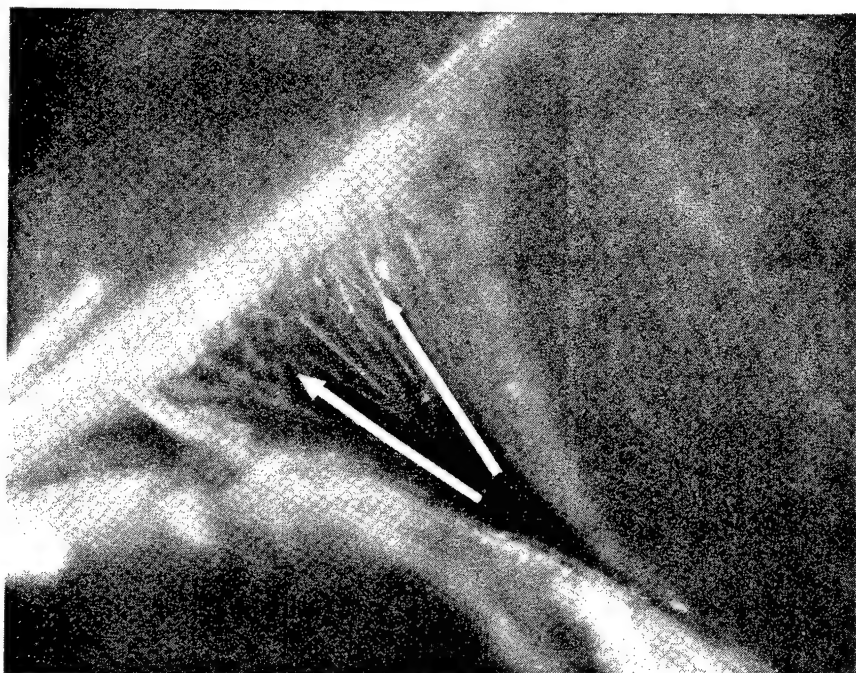
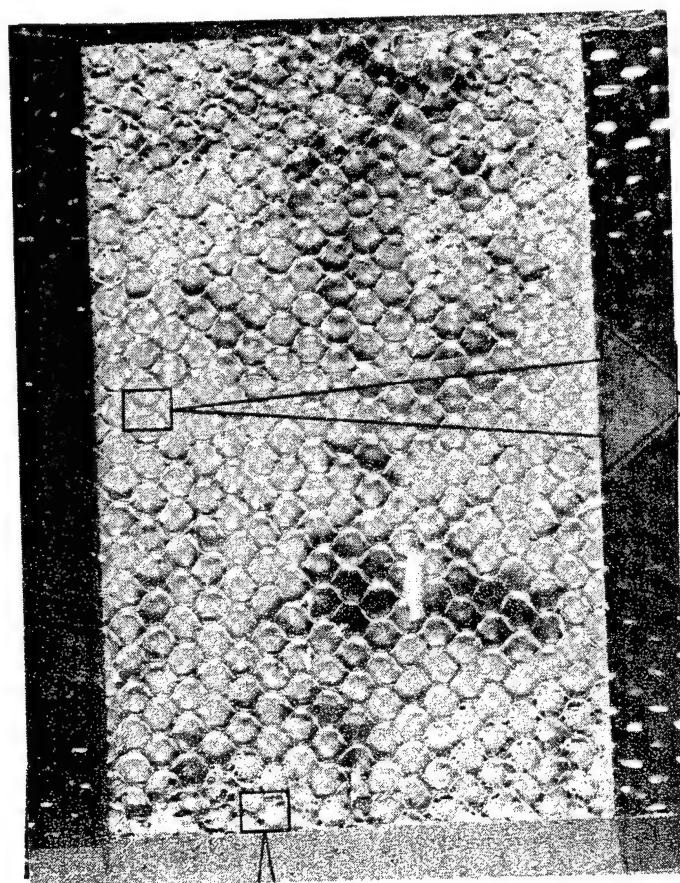
Figure 3.8-12. *Optical Fractographs of Mode I Sandwich Specimen, Undercured Adhesive*  
Sheet 1 of 2

**Undercured Adhesive Specimen.** There was more burst fiber on the failure surface in this sample than in most of the others, except the control specimens, (Figure 3.8-12).

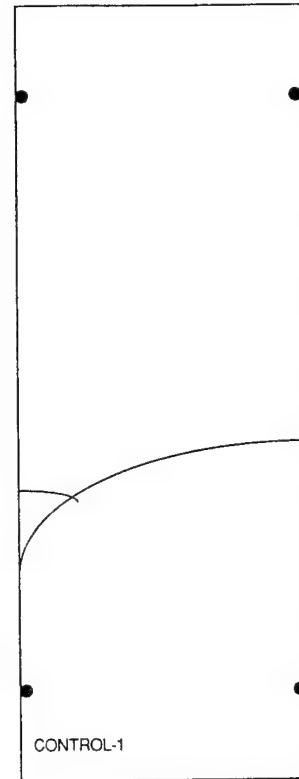
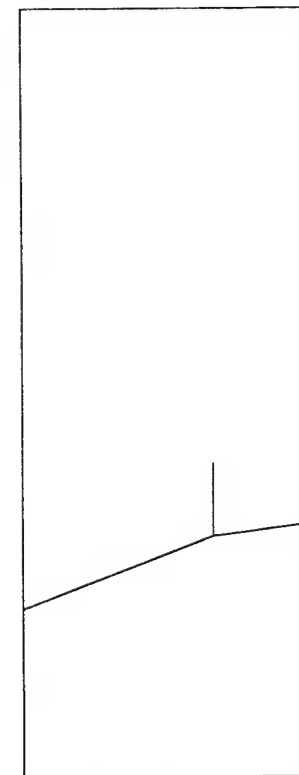
Figure 3.8-16. Control Sample 1—2.4X Reduction

The crack pattern in the honeycomb is illustrated in the edge view drawings. The alternating light and dark vertical bands signify individual cell walls of the honeycomb; walls normal to the edge are now shown. The lines indicate visible cracks in the honeycomb walls, and the thickened surface sheets indicate delamination of the carbon fiber/resin composite, cohesive failure of the adhesive, adhesive failure of the adhesive, or honeycomb fracture at the adhesive meniscus. The type of failure at that surface is identified in Figure 3.8-15. Figures 3.8-16 through 3.8-30 show the specimens and the crack diagrams.

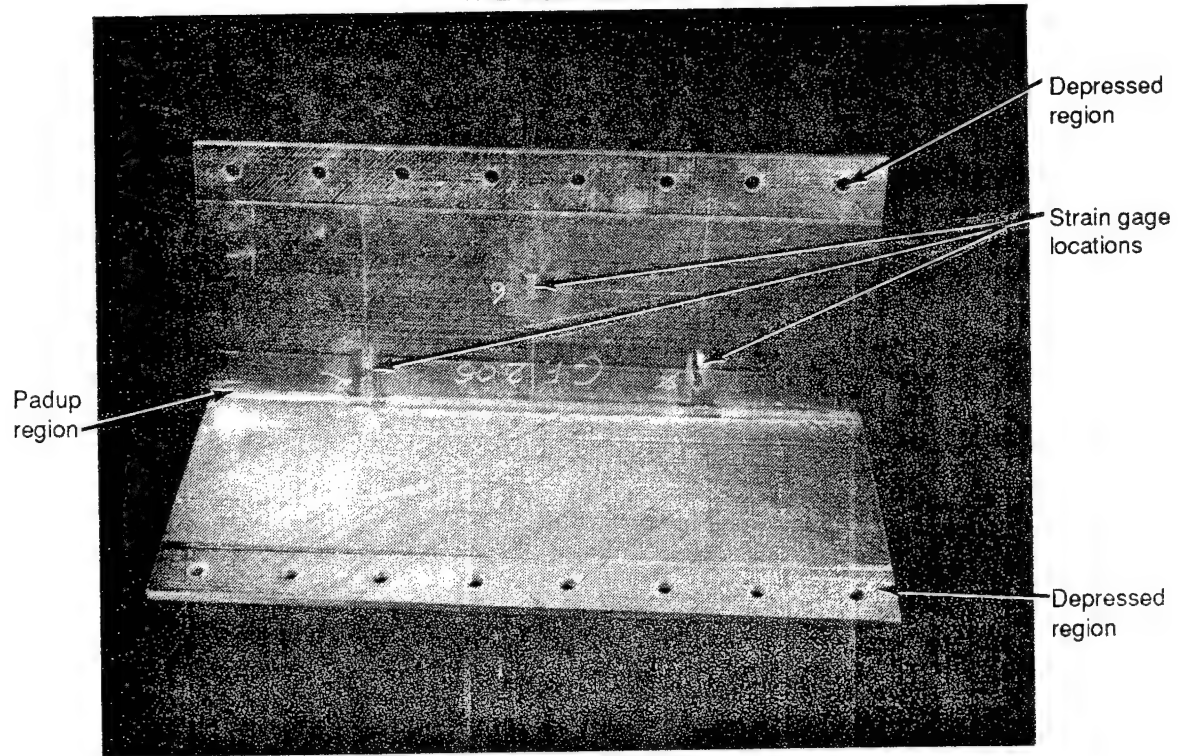
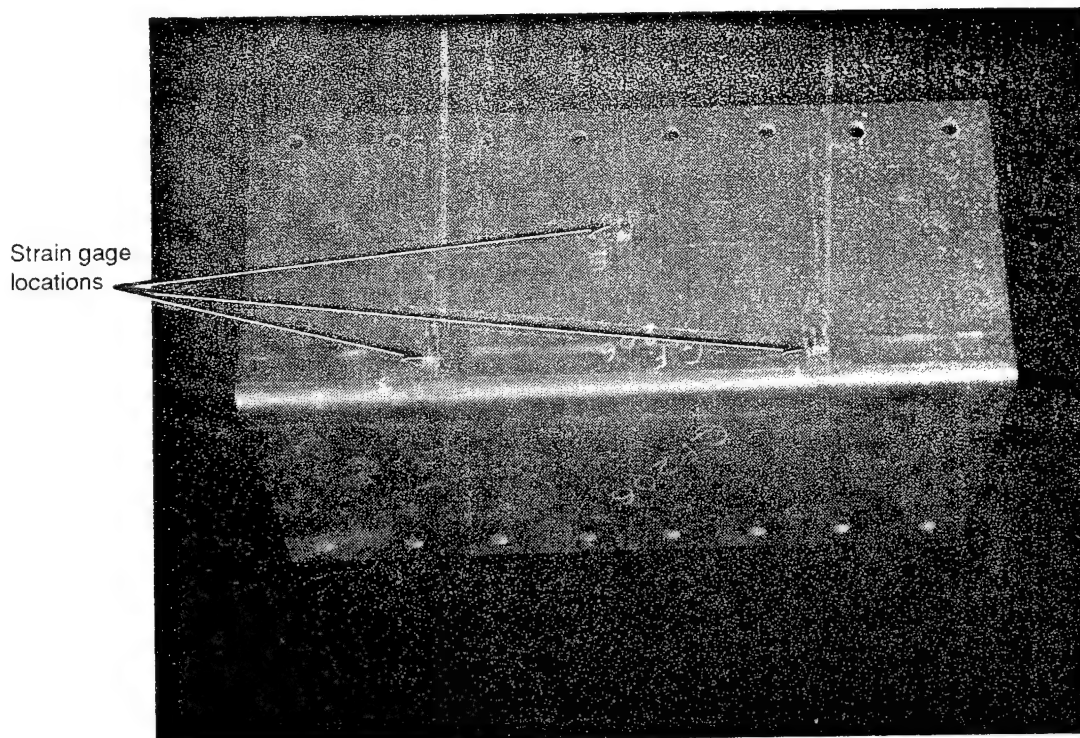
Figure 2. Photographs of the As-Received Component

The submitted component (shown in fig. 2) was approximately 14 inches long with 5-inch wide flanges. The thickness was approximately 0.17 to 0.20 inch. The angle between the two flanges was approximately 95 to 100 degrees. The overall color and appearance was indicative of a carbon fiber-reinforced plastic system.

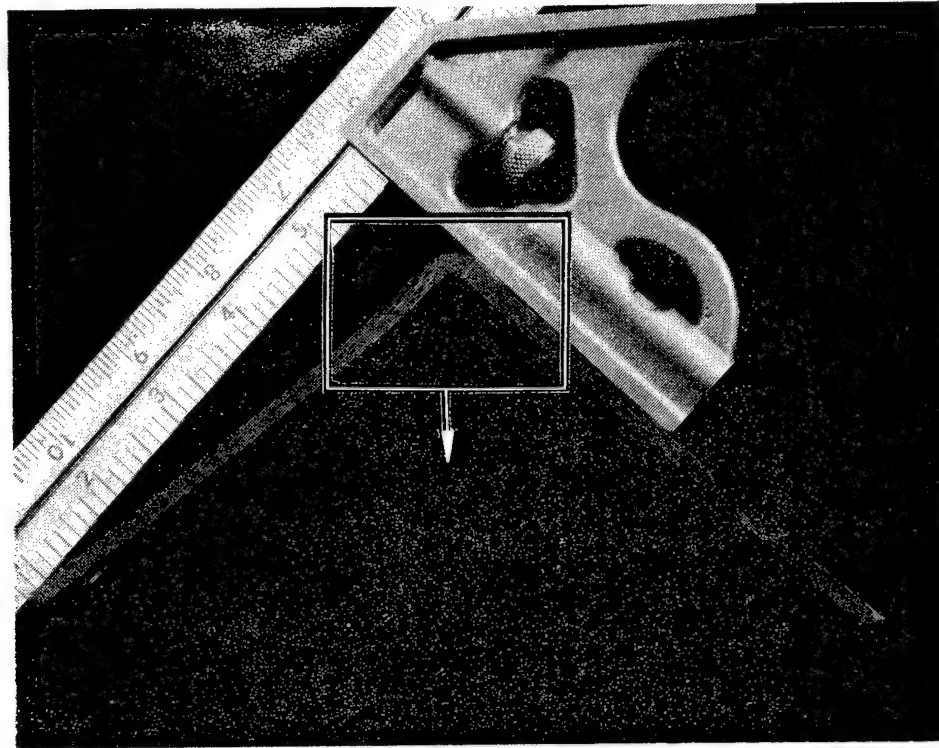
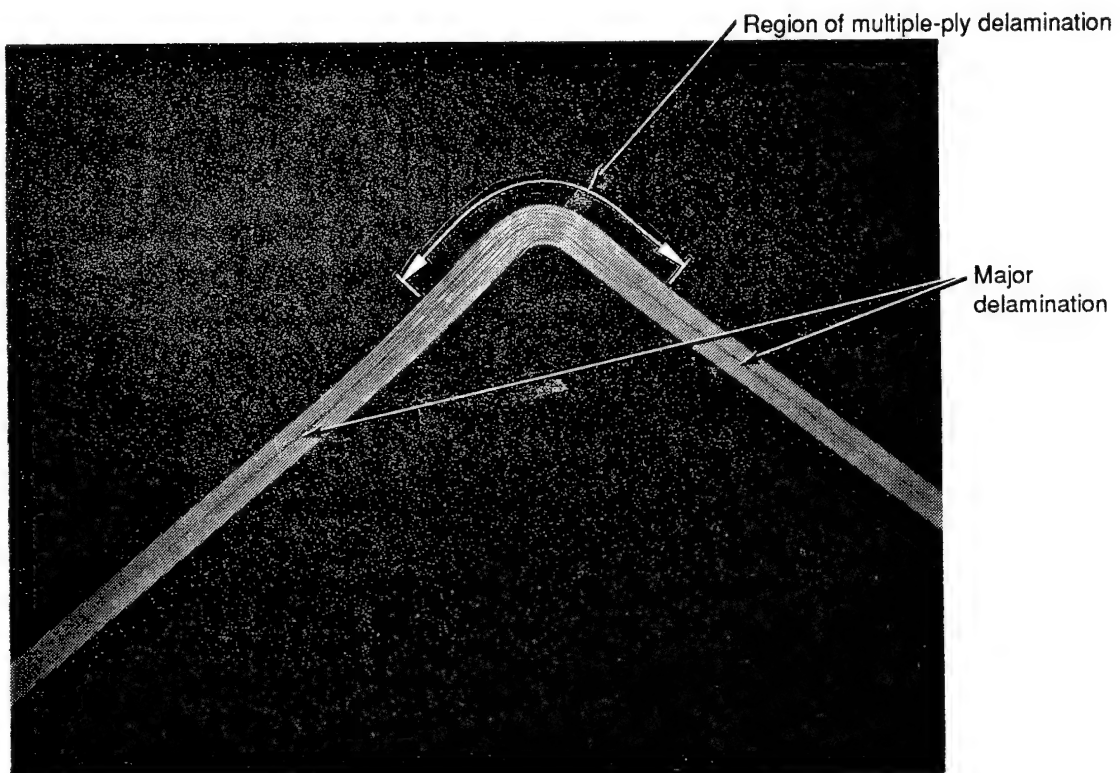
Figure 3. Photographs of the Edge of the Component Showing the Extent of Delamination

Internal delaminations, observe from both ends of the part, extended from the "knee" or angle region to the edges of the flanges (fig. 3). A 3-inch long delamination was located along the center plies. This delamination extended from an inserted ply placed within the center of the fiber plies at the knee region.

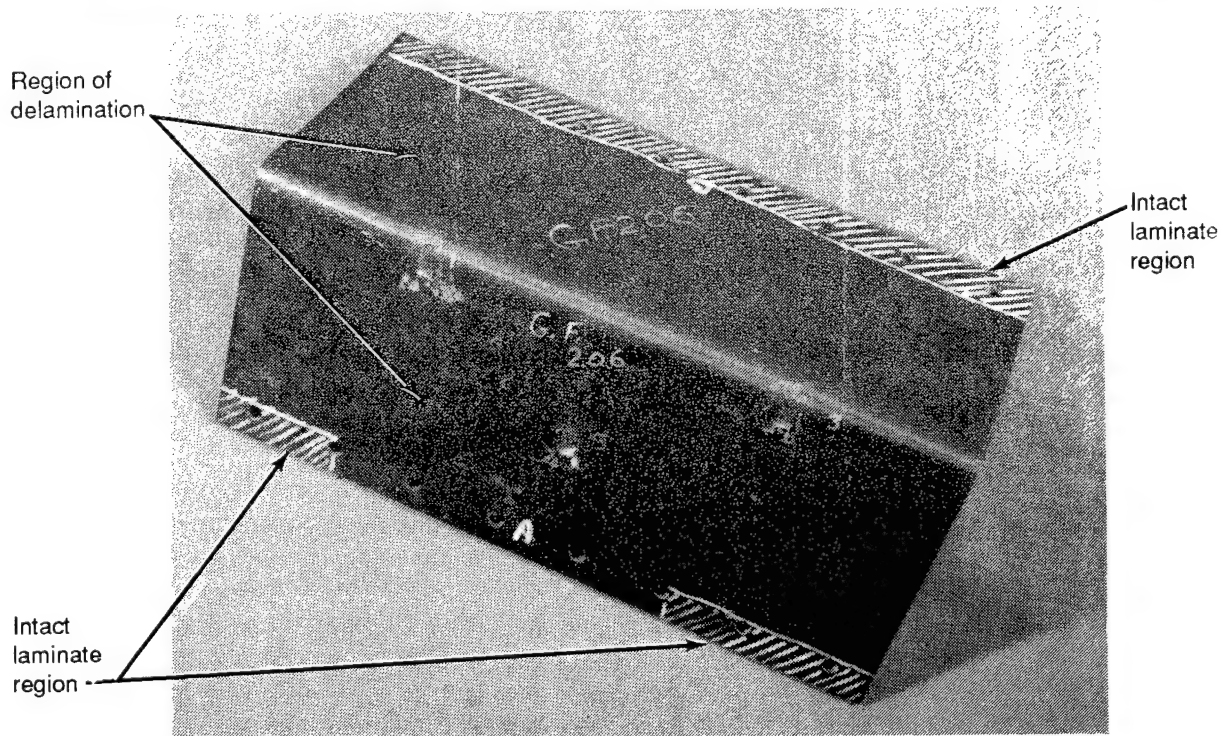
Figure 7. Photograph Showing the Regions of Intact Laminates Identified Using Pulse Echo

Examination using a handheld pulse-echo unit (C-scan) with a .25-inch transducer identified delaminations throughout the component (see fig. 7) except at certain locations along the region containing the fastener holes.

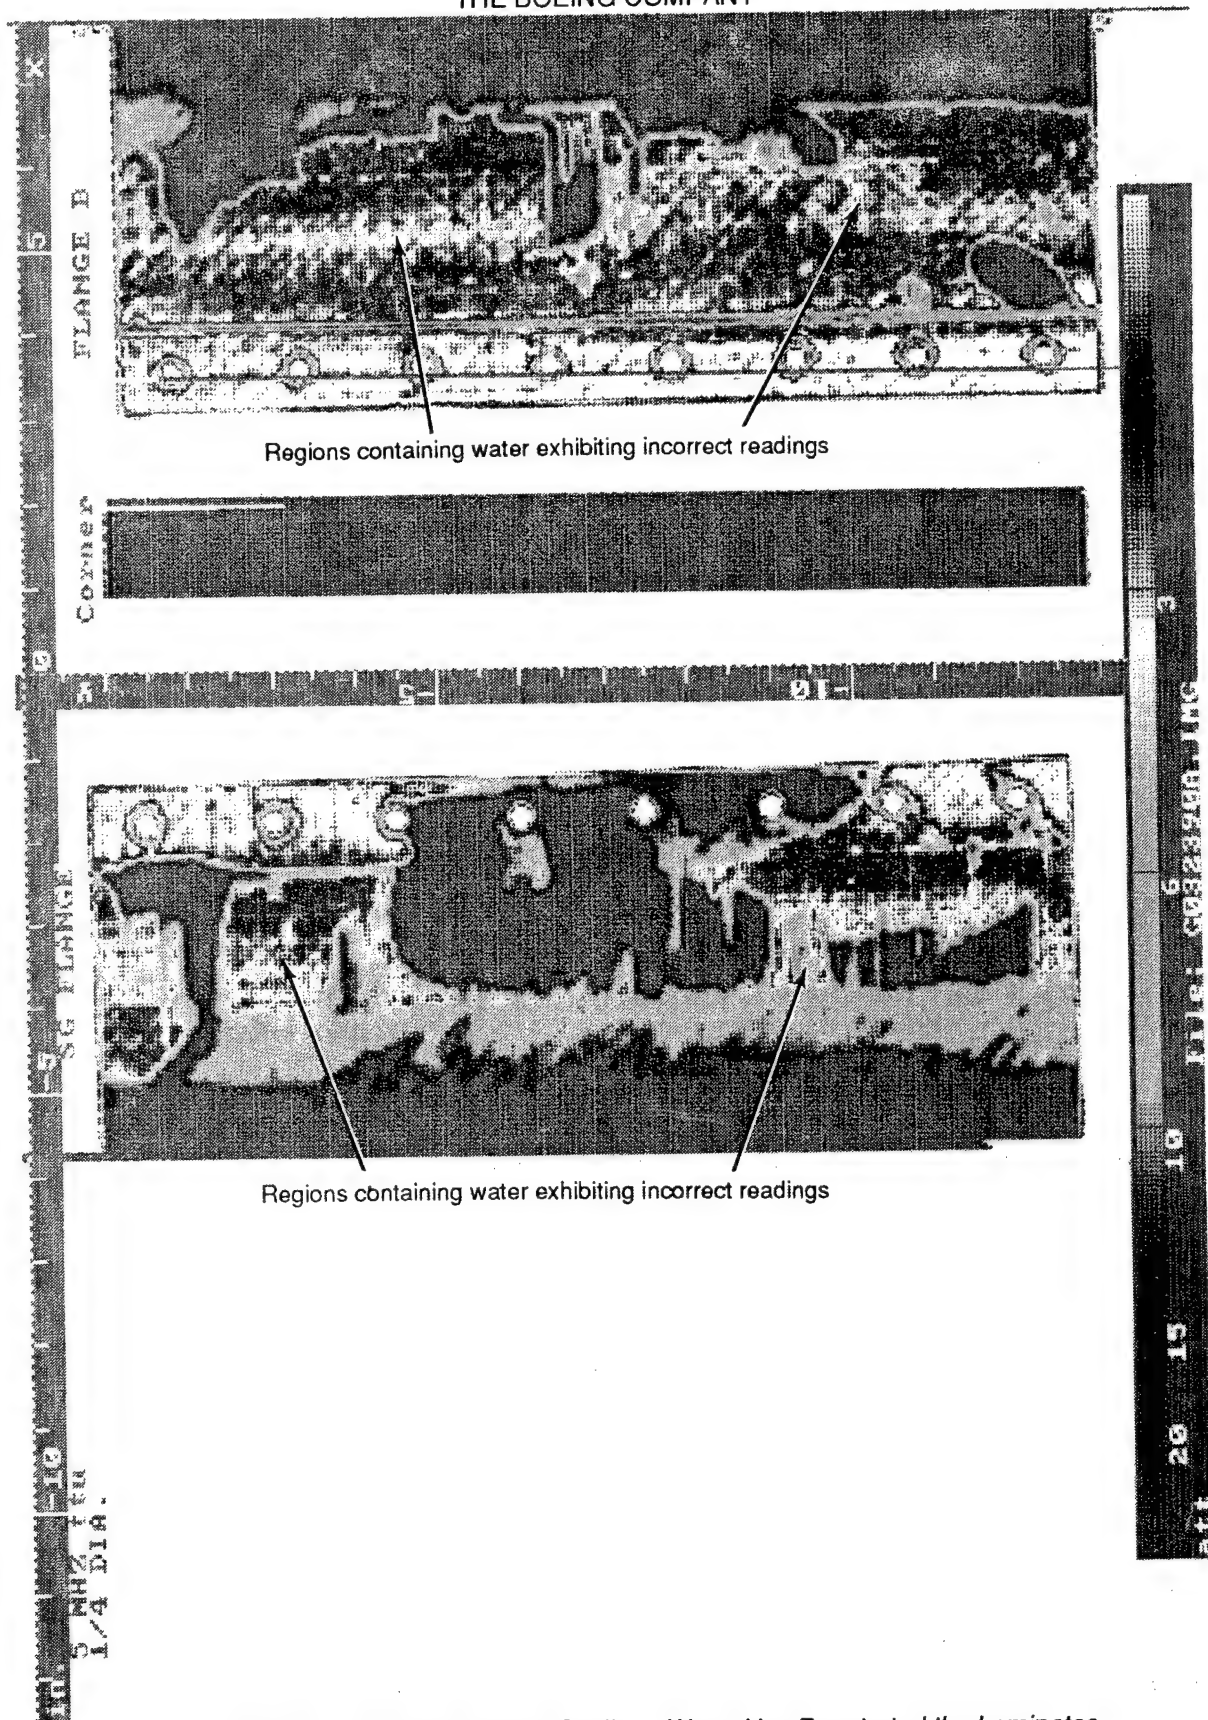
An attempt was made to further characterize the extent of delaminations using TTU (C-scan). However, since the part was exposed to water jets to perform the TTU analysis, large amounts of water entered the part through the edges and caused incorrect indications of delaminations and damage (fig. 8). These were grossly inconsistent with the pulse-echo analysis.

Figure 8. TTU Scan Before Sealing. Water Has Penetrated the Laminates From the Edges Causing Incorrect Readings

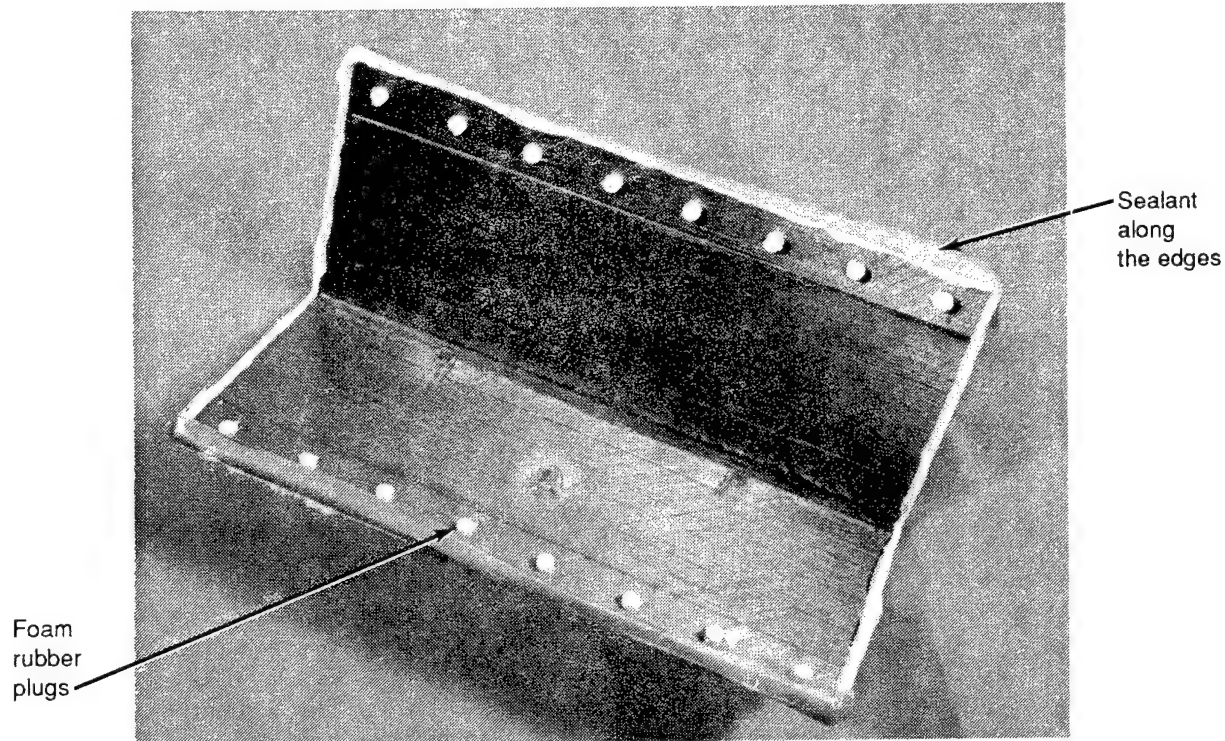
*Figure 9. Photograph of the Part After the Edges and Fastener Holes Were Sealed Before the Second Series of TTU Scans*

The part was subsequently dried in an oven at 90°F for 30 minutes before another set of scans was performed. This time the edges were sealed, the surface of the part was sprayed with a lacquer, and the fastener holes were plugged (fig 9). The part was then rescanned which revealed that it was almost completely delaminated (fig. 10). The grip areas were not delaminated as observed in the pulse-echo analysis.

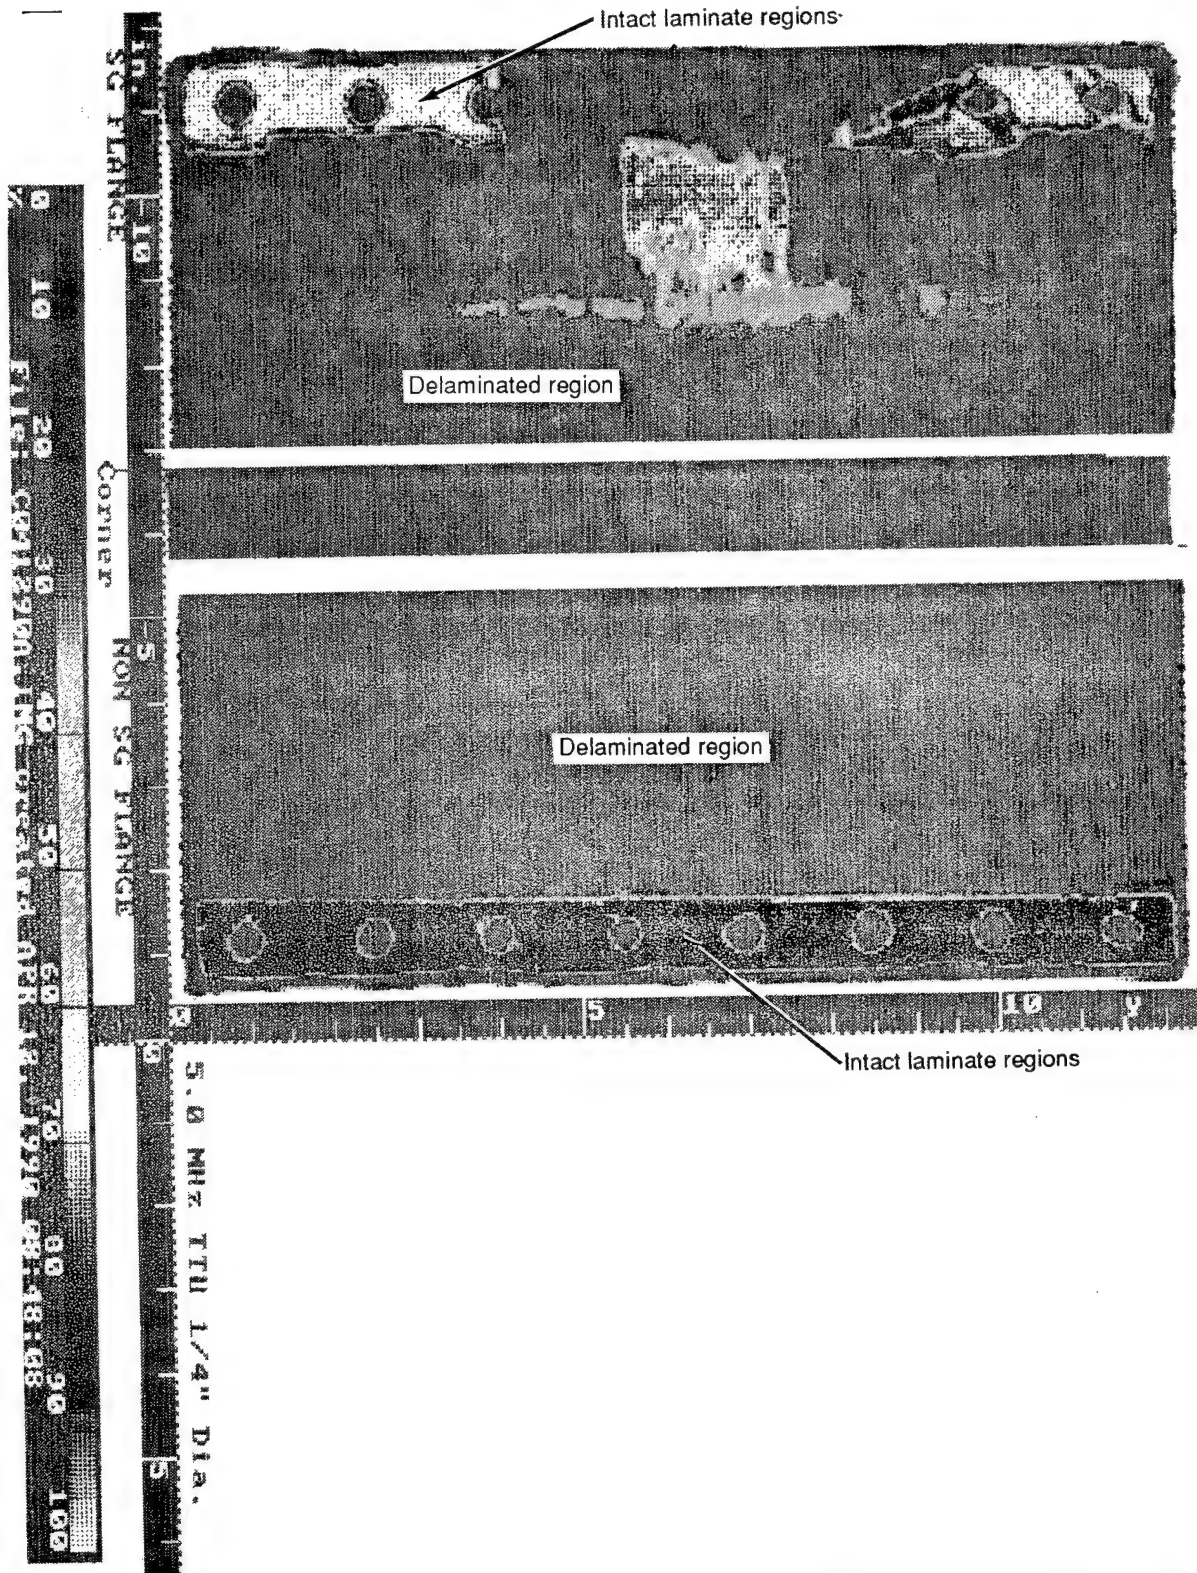
Figure 10. TTU Scan, After Drying and Sealing the Component, Exhibiting Delamination Regions Similar to the Pulse-Echo Examination

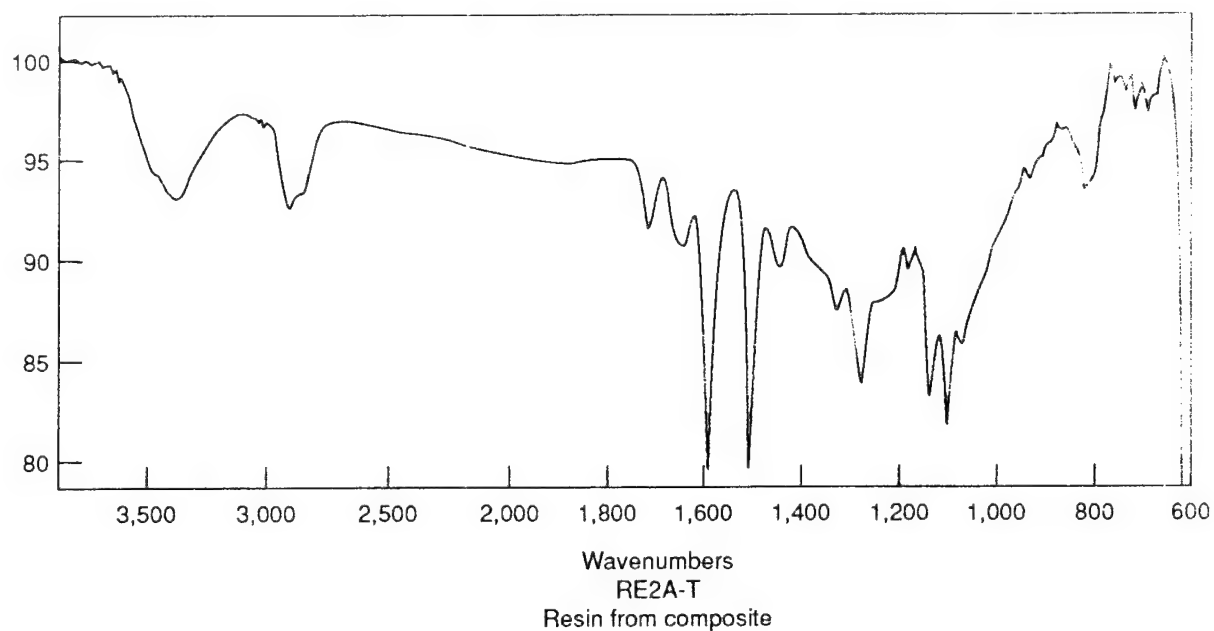
Figure 12. IR Spectrum From a Sample of the Resin From the Component

The resin material was examined using infrared spectroscopy analysis (IR). This identified the material as similar to the Hercules 3501-6 epoxy resin system (figs. 11 and 12). This material has a curing temperature of 350°F. IR also identified the peel ply material to be a Teflon/Fiberglass film.

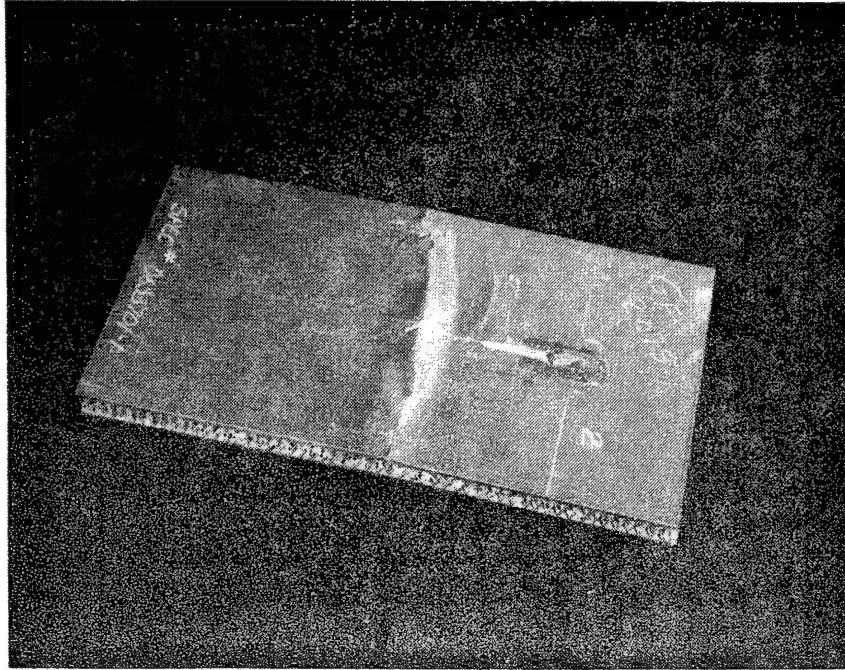
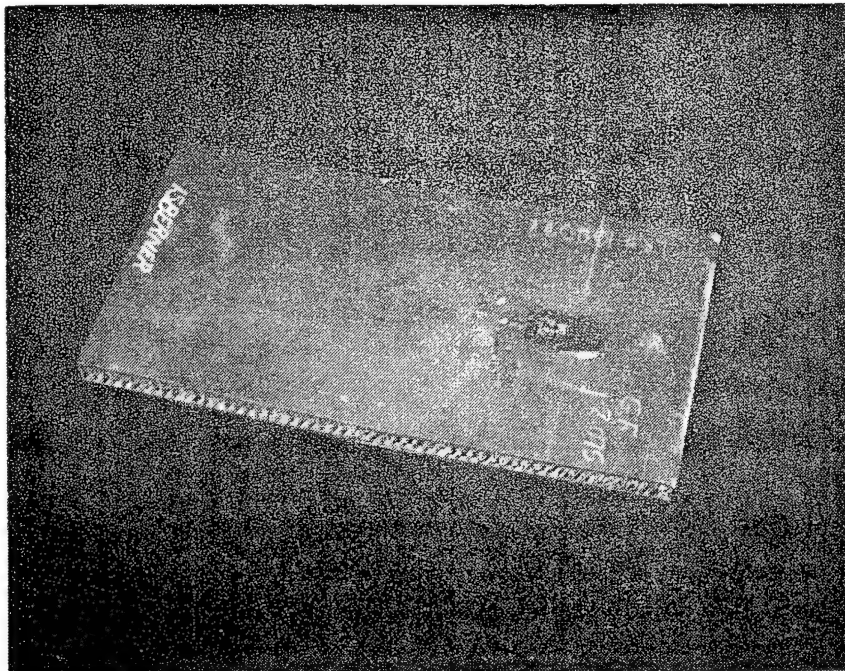
Figure 2. Photographs Showing the Top and Bottom Surfaces of the As-Received Component

The component was a rectangle metal honeycomb sandwich panel with carbon fiber composite face sheets. It was approximately 0.6 inch thick, measuring 9.0 inches by 6.0 inches (see Figures 2 & 3). The top surface contained a transverse bulge located in the middle of the panel approximately 1 inch wide. The bottom surface was generally warped. Examination of the honeycomb core along the edges revealed that all of the honeycomb core was damaged (see Figure 3). However, no honeycomb/adhesive failures were observed, only the cell walls were deformed with the bonds to the facesheets being intact.

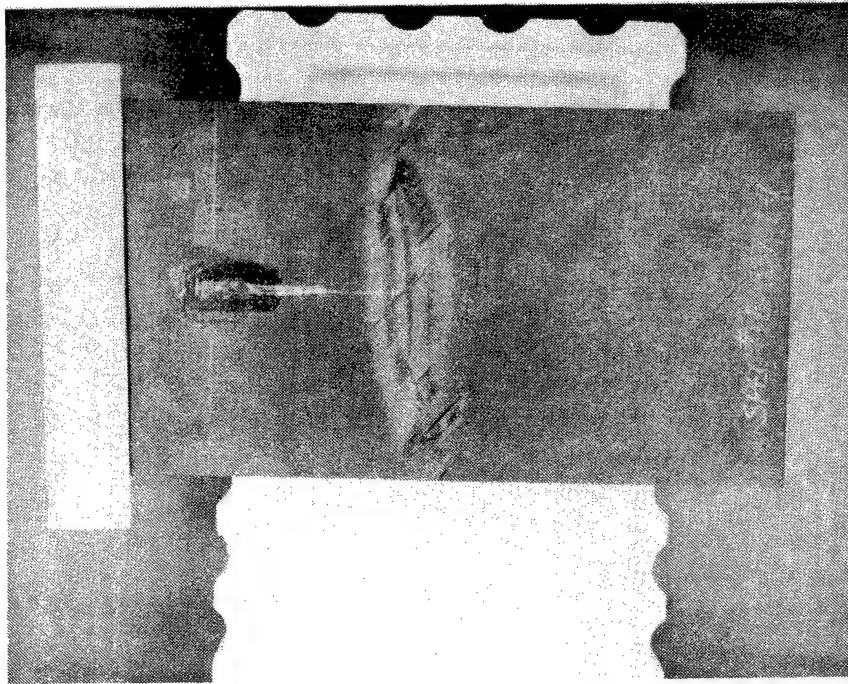
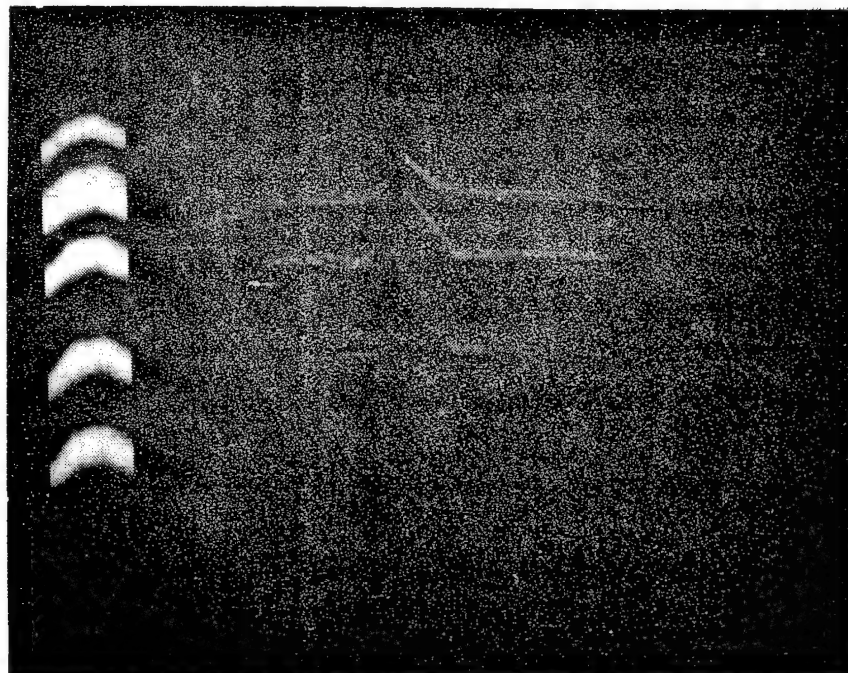
*Figure 4. Buckled Surface Showing the Angled Slit Lighting Contours*

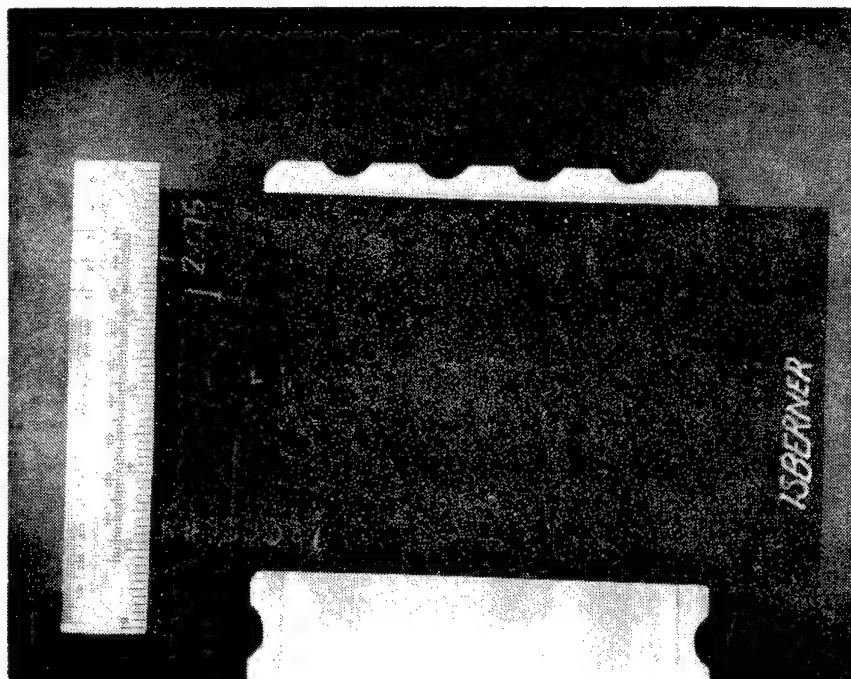
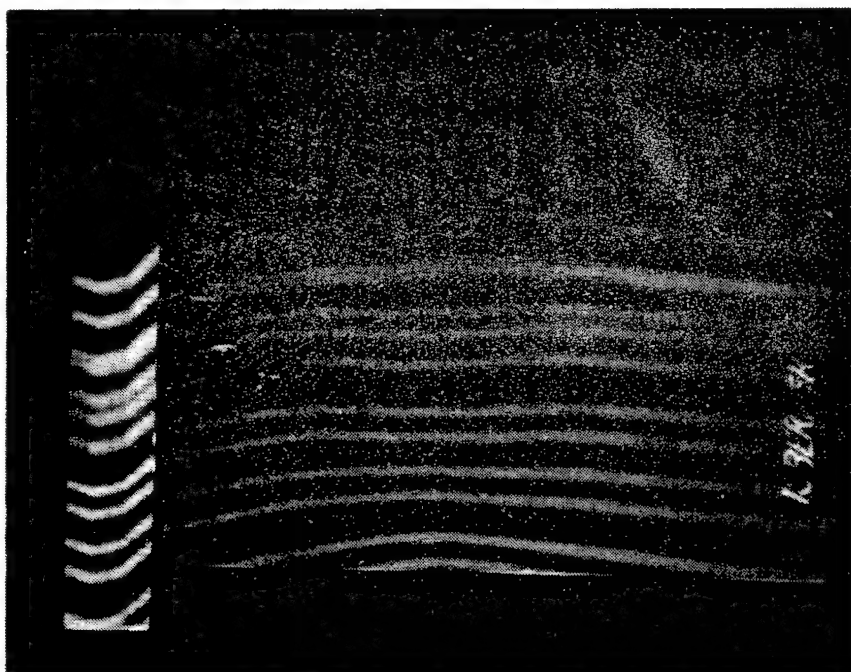
Figure 5. Smooth Surface Showing the Angled Slit Lighting Contours

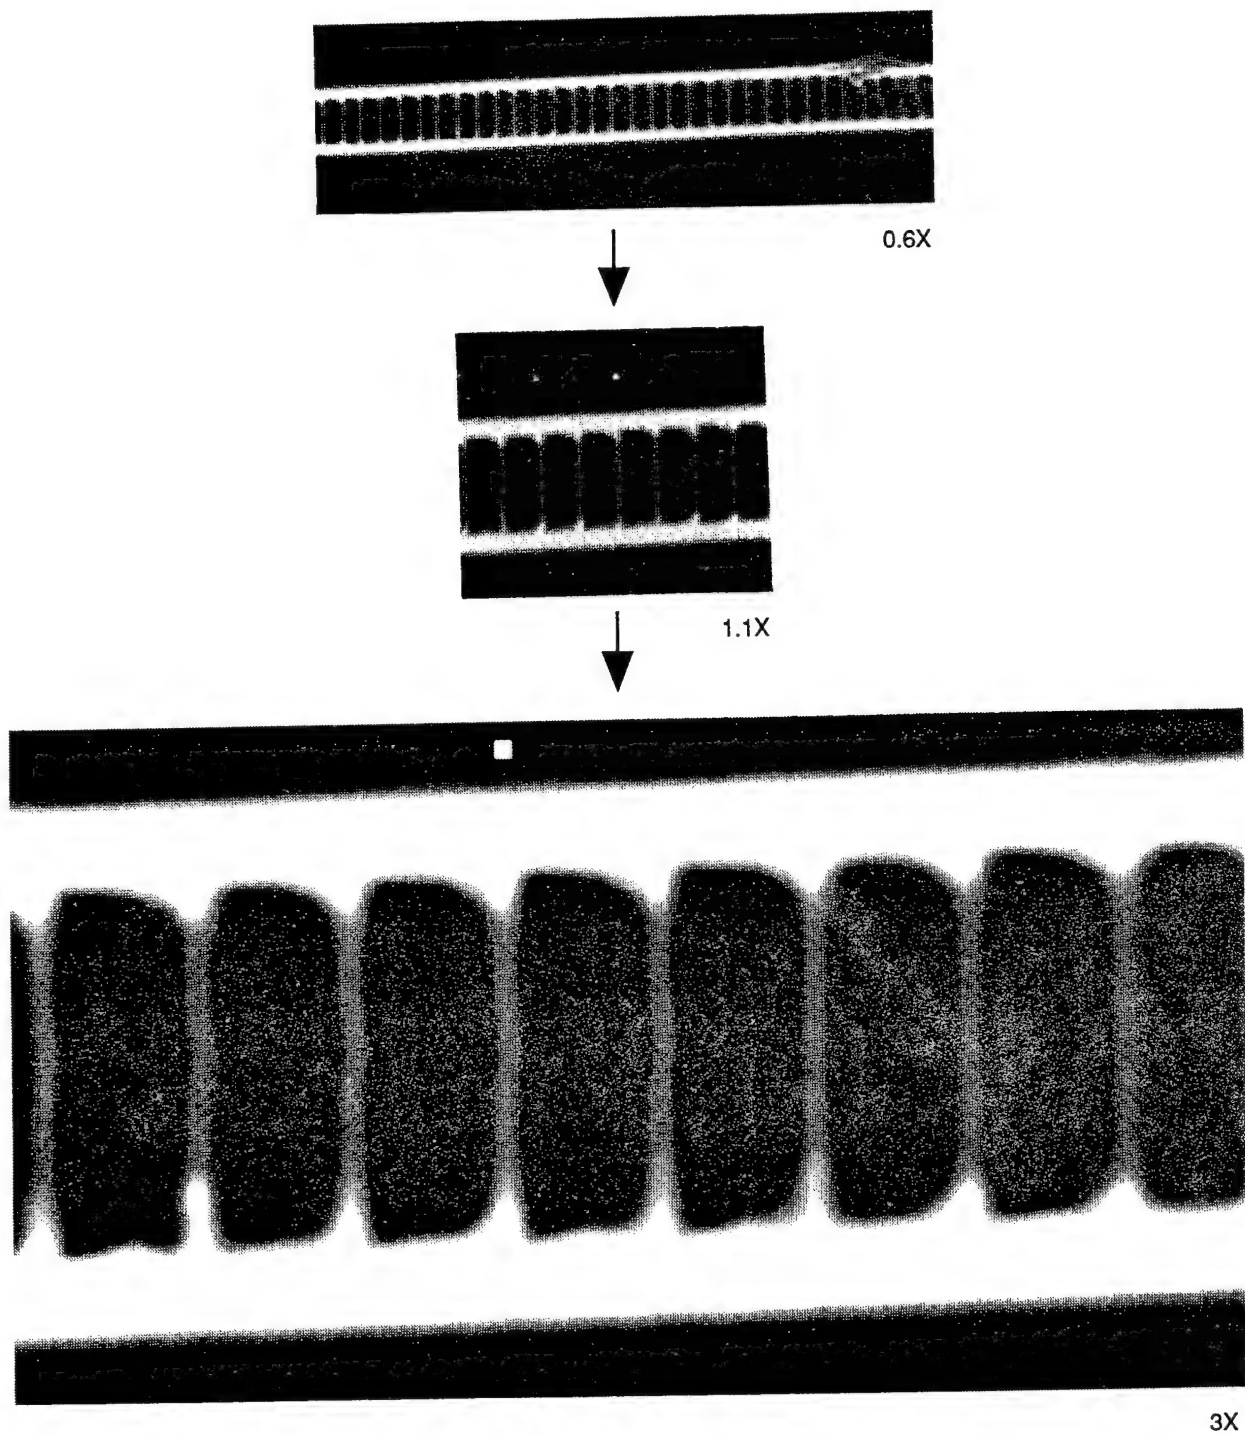
Figures 8 through 11 through show the various images of the slices through the component. The longitudinal slices 1, 2, & 3 show the damage present in the honeycomb regions in the center of the component. The front half of the panel appears to have been crushed by a macroscopic shearing of the upper front half of the facesheet. The back half exhibited little if no damage. However near the bulge, the core appeared to be crushed in the short transverse direction. There was no evidence showing any longitudinal buckling trends to either end (from one end to the other). This transverse damage was located all along the back half of the component.

Figure 9. CT Images of the First Longitudinal Scan

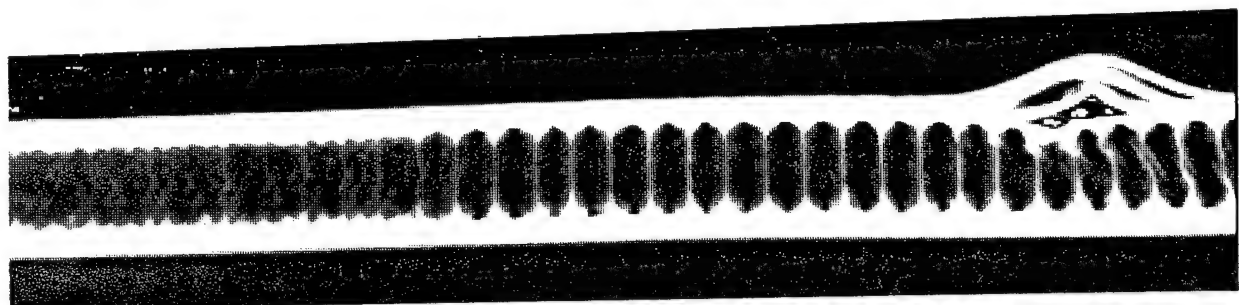
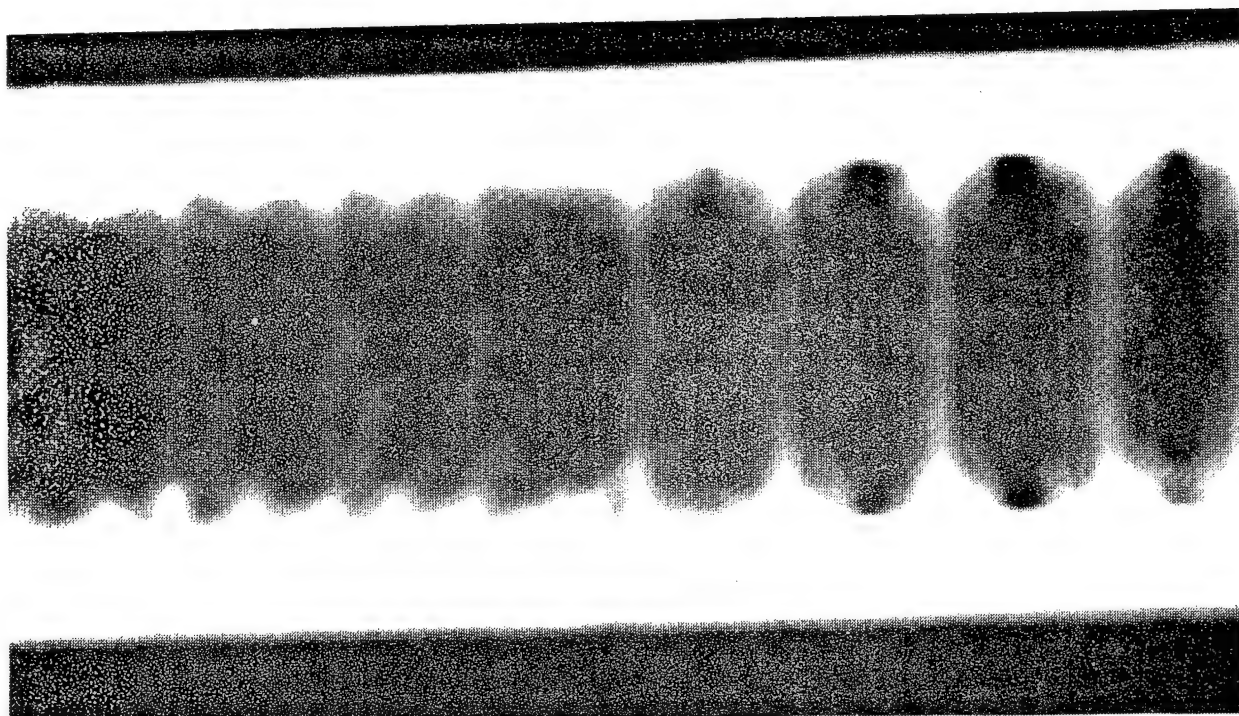
*Figure 10. CT Images of the Second Longitudinal Scan*

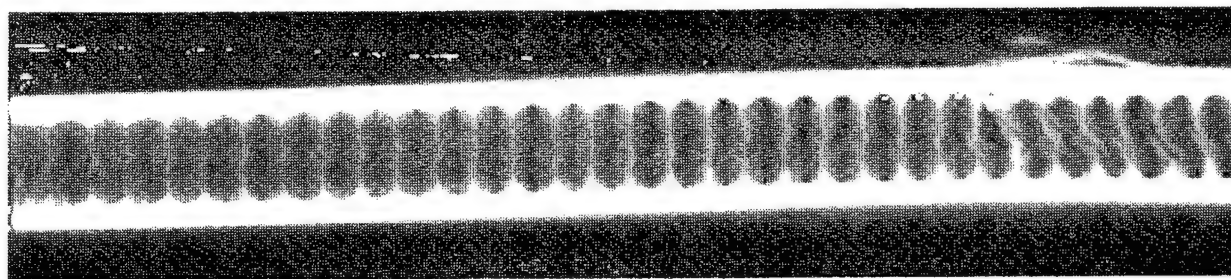
*Figure 11. CT Image of the Third Longitudinal Scan*
